RÄDDNINGSTJÄNSTEN STORGÖTEBORG

Accident investigation

Fire in container for battery energy storage, Gothenburg 2023-04-26

Fire in container for battery energy storage Sisjön industrial area Gothenburg 2023-04-26

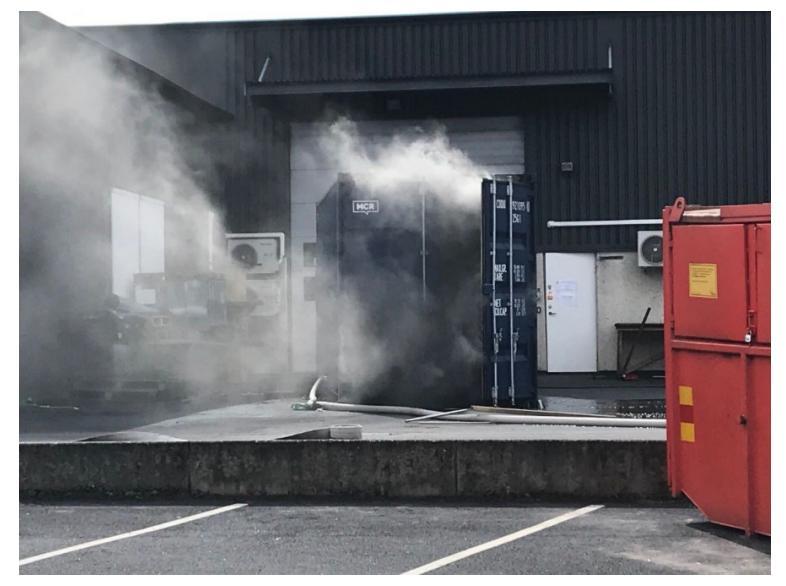
Picture 2 shows the container early in the operation. Source RSG

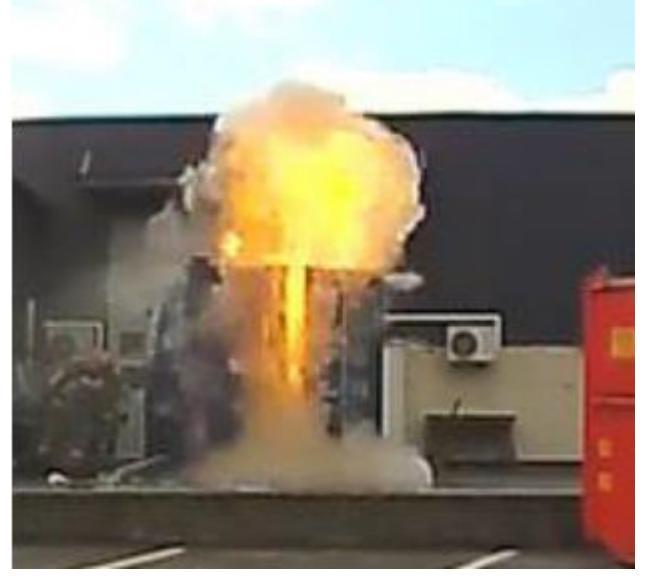
about 4 – 5 minutes after cooling with cutting extinguishers started, a strong explosion occurred which deformed the container and where the doors on one short side of the container flew open.

Image 3 shows a clip from a film that captured the explosion. Source current company

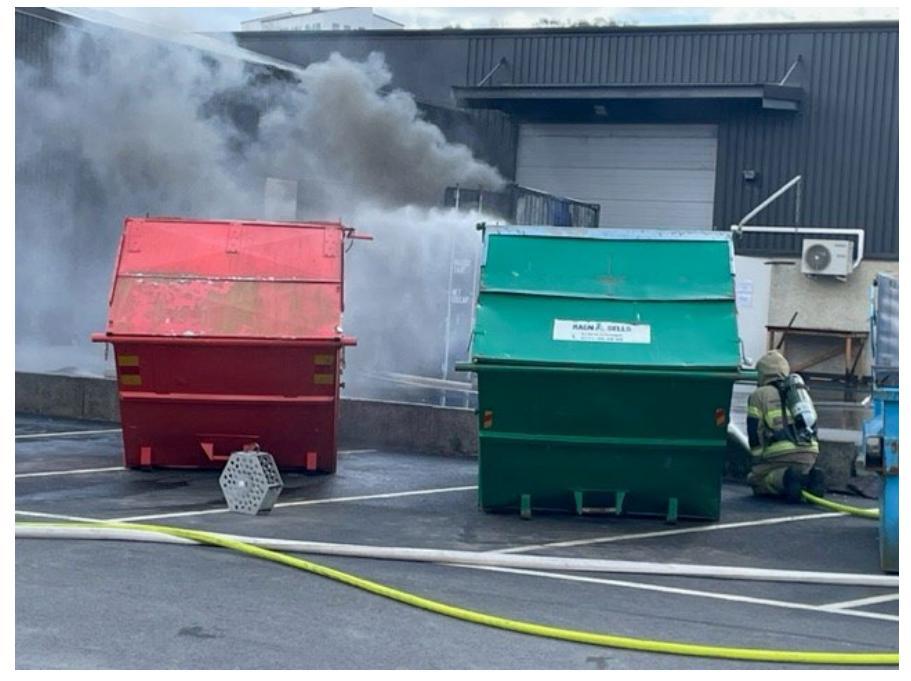
Figure 4 shows smoke development and work from a protected position. Source RSG

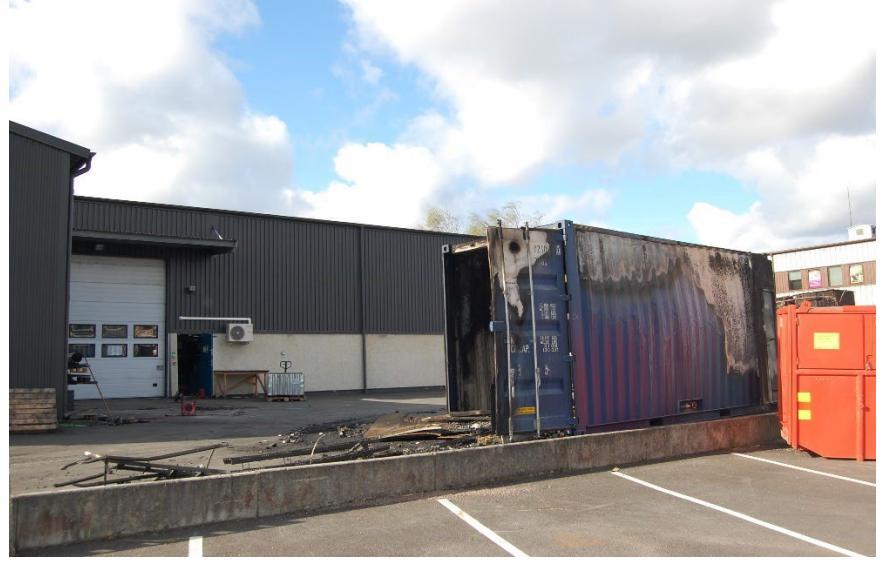
Picture 5 shows the new location of the container. Source RSG

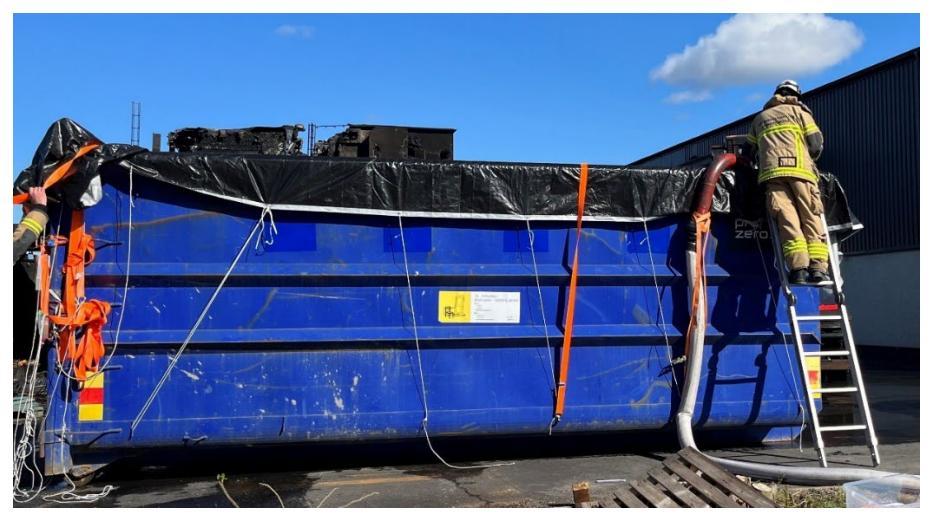
After just over 1.5 hours after the end of the rescue operation, a new 112 call was received, where it emerged that smoke had once again started to come from the batteries. RSG started a new rescue effort where initially a risk distance of 50 m was kept and the plan was once again to get a container that could be filled with water and then submerged in the batteries. They had contact with expertise that meant that in itself is there any additional danger with this type of reboot other than just continuing to cool. A few hours later, the company had produced a container that was coated on the inside with pressing and then filled with water. With the help of a crane truck, the battery was then lowered in its entirety for cooling.

Picture 6 shows the battery immersed in a water bath. Source RSG

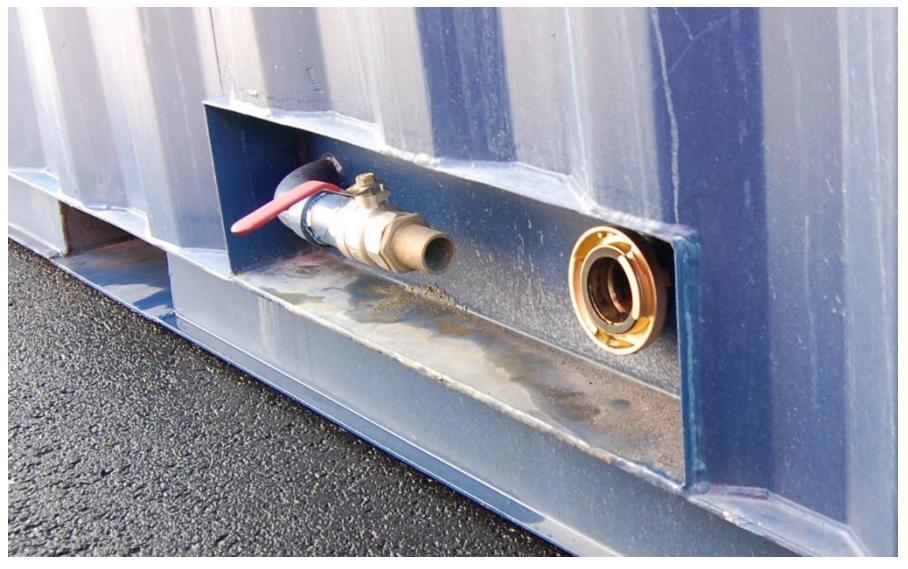
Picture 8 Shows the connection for the introduction of water on the right and emptying on the left. Source RSG

This inlet was connected with hose from RE early in the operation but water application was not started. The company's representative announced in connection with the information about the introduction that "using this method destroys all batteries". That information together with other assessments led RL to decide at the time to start the operation with the method of containing, inerting and cooling the fire gases using the cutting extinguisher described above. When the explosion resulted in the container being deformed, cooling via introduction was no longer relevant.

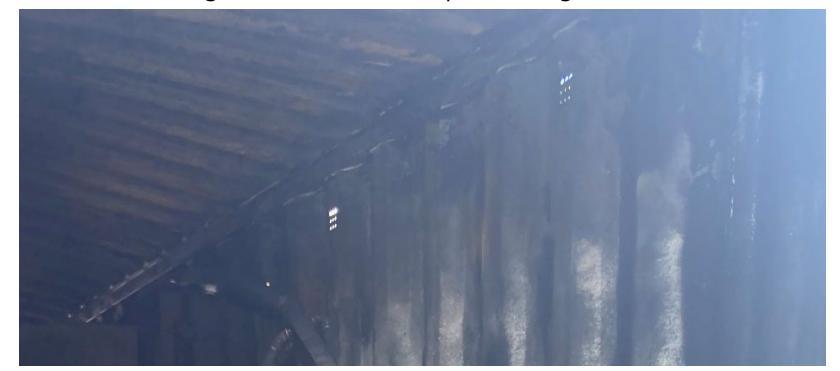
in the current case, the investigator was able to find ventilation in the container. However, it is unknown how large a volume of air can pass through this ventilation and at what rate.

Picture 9 shows two of eight ventilation openings. Source RSG

It also requires that the water be applied to the top of the container so that rising water pressure does not affect the filling. According to the description, the pipe must have been constructed in this way. The deformation of the container in connection with the explosion suggests that pressure relief hatches for sudden pressure increase were missing.
